Reduction of Black Carbon from Diesel Sources in the Russian
Arctic-TUNDRA Reindeer Farm

Arctic Contaminants Action Program (ACAP) Working Group

Reduction of Black Carbon from Diesel Sources in the Russian Arctic- TUNDRA Reindeer Farm

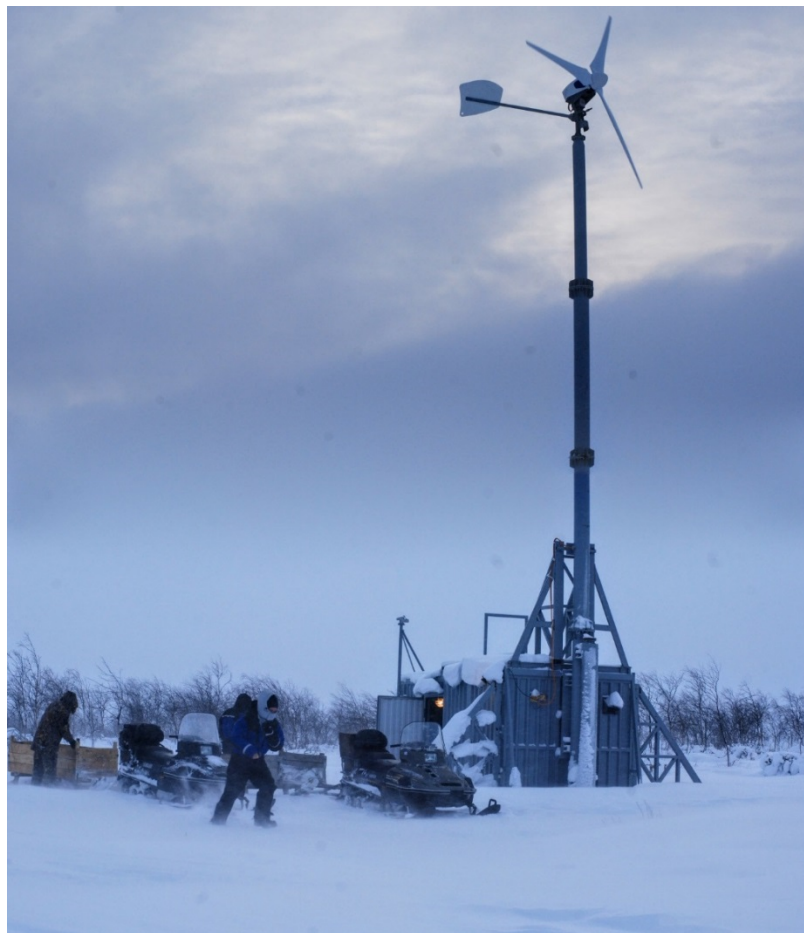
Front cover: Wind turbine and generator with container unit at Tundra Agricultural Cooperative - Polmos Reindeer Farm

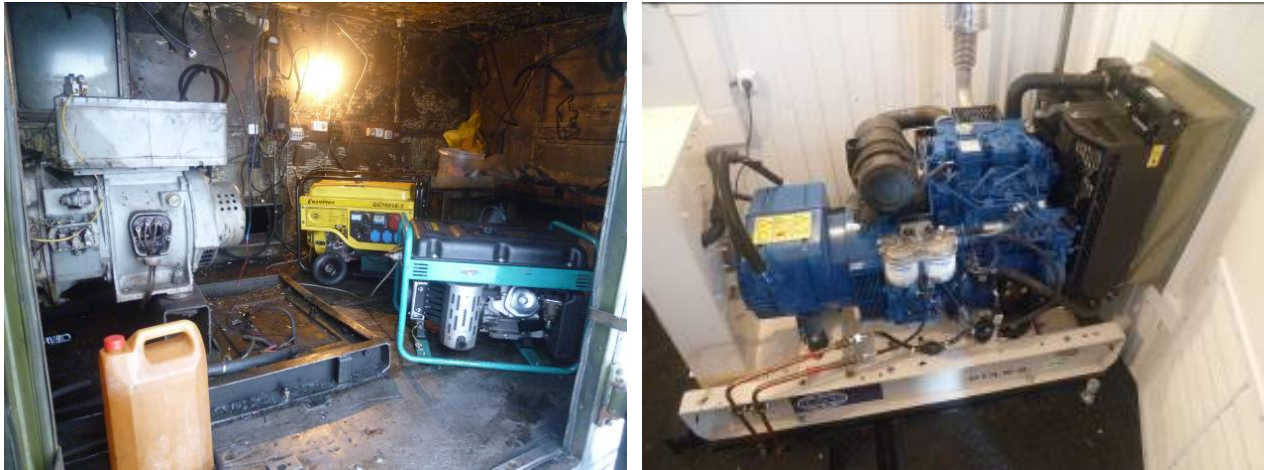
Old 10.4 kW diesel generator (left) and the new, more efficient 10.8 kW diesel generator

- Container module with mounting structures for wind power installed
- Wind power 5 kW with 12-meter mast installed
- Diesel generator 10.8 kW installed and tested

- According to commissioning protocol the new wind power and diesel generator were put into operation in the beginning of June 2015. The power supply system worked in an automatic mode. During this period the installation was also tested during strong winds. According to the experts, the installation successfully switched to safety mode under strong wind loads. The old diesel generator was taken out of service in June 2015

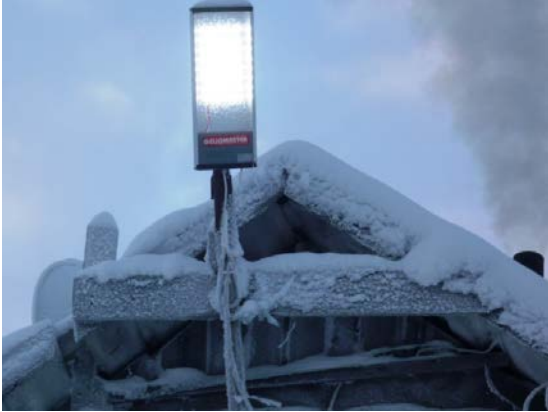
LED lighting installed throughout site to reduce energy consumption

- 10 units of LED floodlights were purchased and delivered to the Tundra Polmos base
- LED Lighting system was installed in October 2015.

- One of the lighting fixtures has yet to be replaced; this should be done in the near future. Indoor lighting was replaced with fluorescent lamps instead of LED lighting as was recommended by the Consultant.

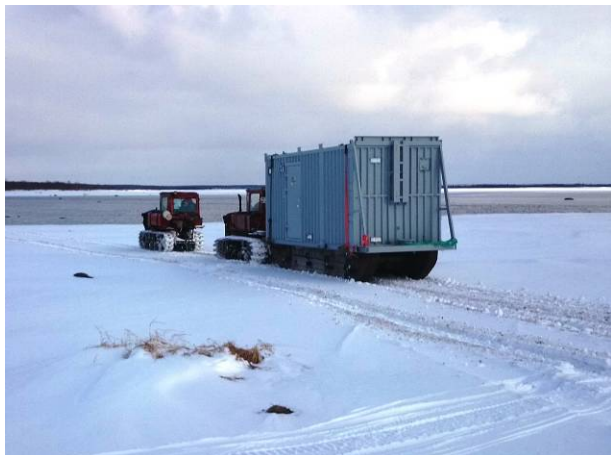
Transportation to Polmos often requires tractors or tanks to traverse the tundra

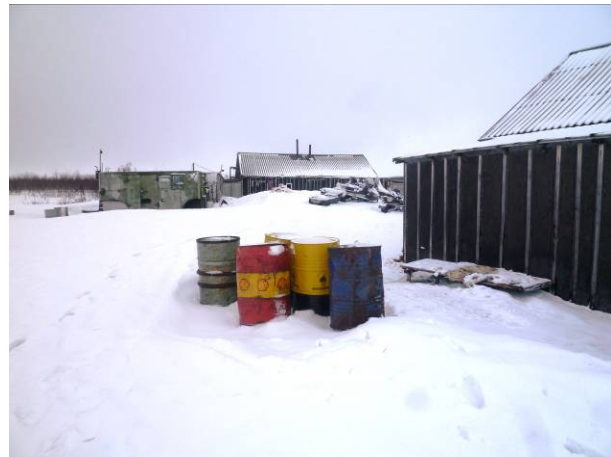
Diesel fuel at Polmos stored in barrels near bunkhouses

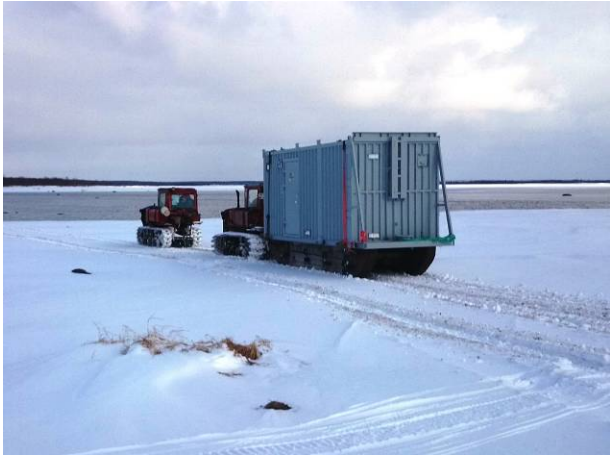
Transportation of the equipment

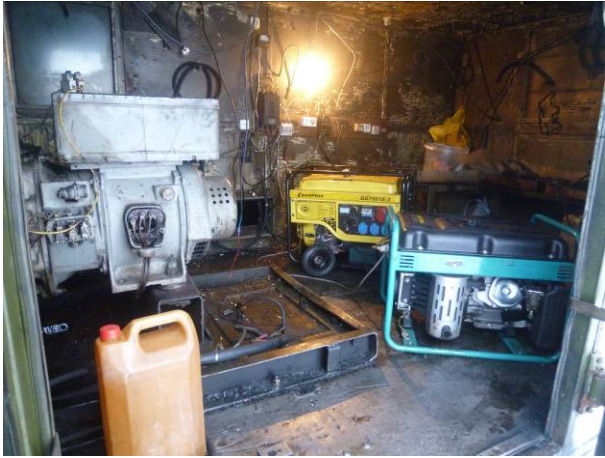
Old diesel generator

- The old diesel equipment was disposed-off in January 2016.

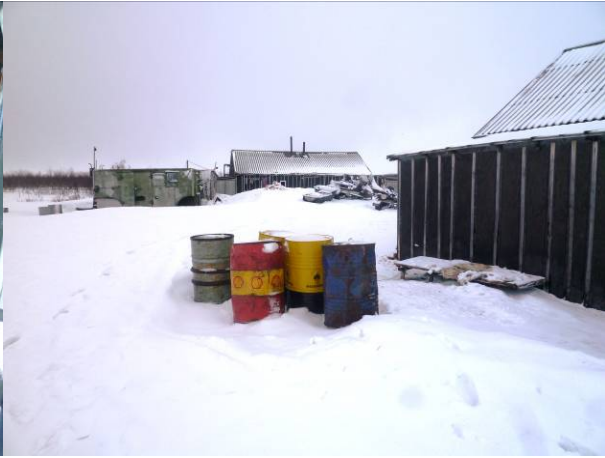
Barrels of diesel fuel

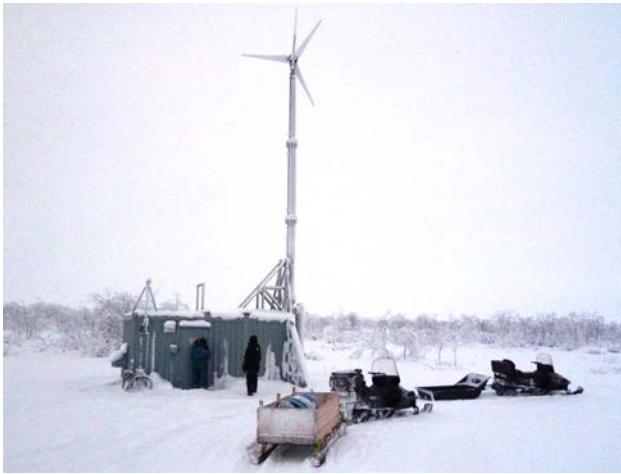
New wind-diesel plant

- Expectations of the Tundra representatives regarding strong winds in the area of wind-diesel installation were unfounded. As workers informed the project, there are many days without wind or only with very weak wind. At the same time during the period of wind-diesel operation the wind generator was switched to spin mode twice due to squall winds. During the last field visit by the S&M Consultant the wind generator also did not produce power due to calm weather.

- Due to the fact that wind-diesel installation is located 750 m away from the base, it creates some difficulties with operation considering that the old installation was located directly on the Polmos-Tundra base.

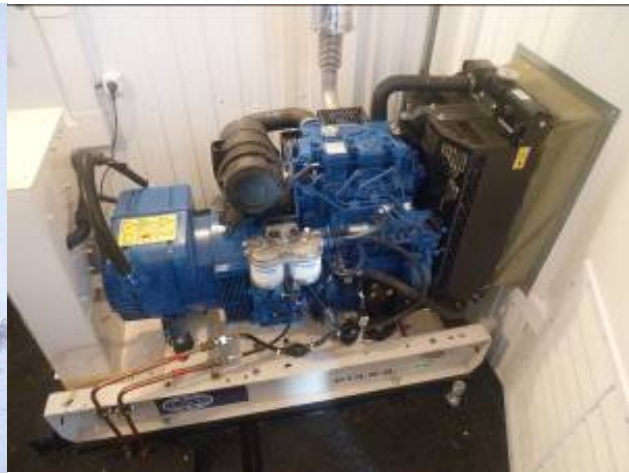
New diesel generator

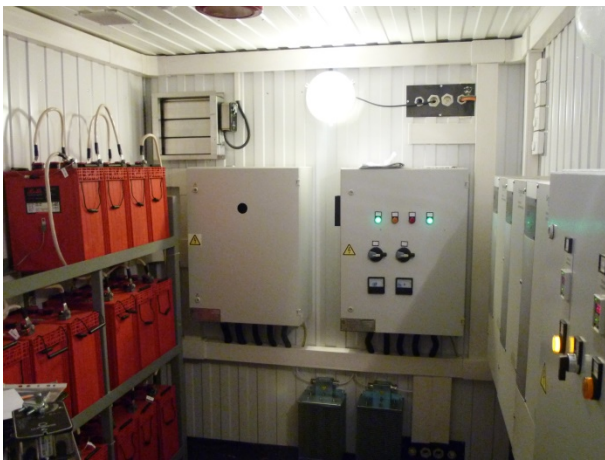
Accumulators

Inverters

- The indoor temperature in the container is set for 20°C (for optimal operation of the accumulators, as explained by the Equipment Supplier). As noted from the meter data registration, about 50% of the energy consumed by Polmos-Tundra Base is used by the container. This significantly influences the fuel consumption of the new installation. The Consultant contacted Supplier to discuss whether the set temperature could be reduced.

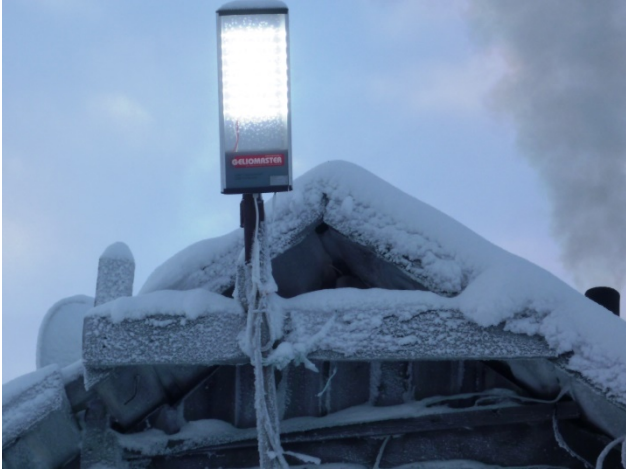
Lamp with a mercury lamp DRL 250

New LED lighting GSS-40
